Precision Property Inspections, LLC.

Home Inspection Report

2543 Silver Maple Lane, Denver CO, 80290
Inspection prepared for: Happy Homebuyer
Agent: Joan Realtor -

Inspection Date: 8/12/2010 Time: 2:30 PM
Age: 1995 Size: 2197 Sq. Ft.

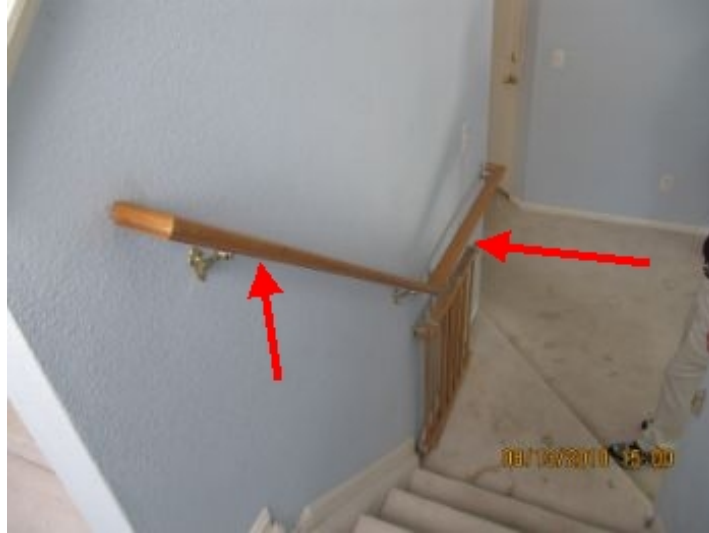
Observations: Wall mount rail on lower set loose, needs to be secured to be safe. • Consistent rise, railing and handrail in place.

Loose railing

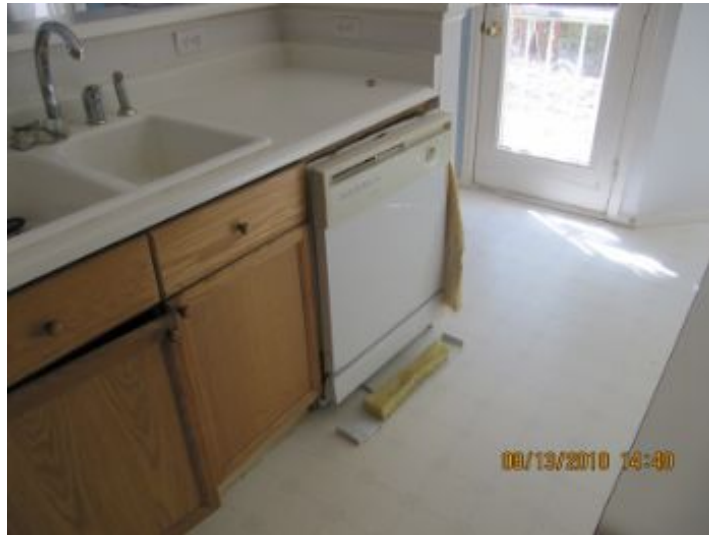
Observations: Inoperable, drain not hooked up, partially pulled out from under the countertop.

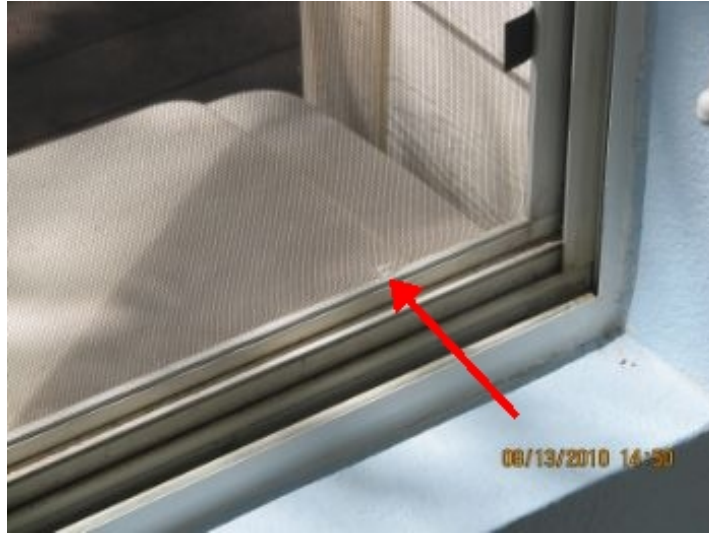
Observations: Damaged screens

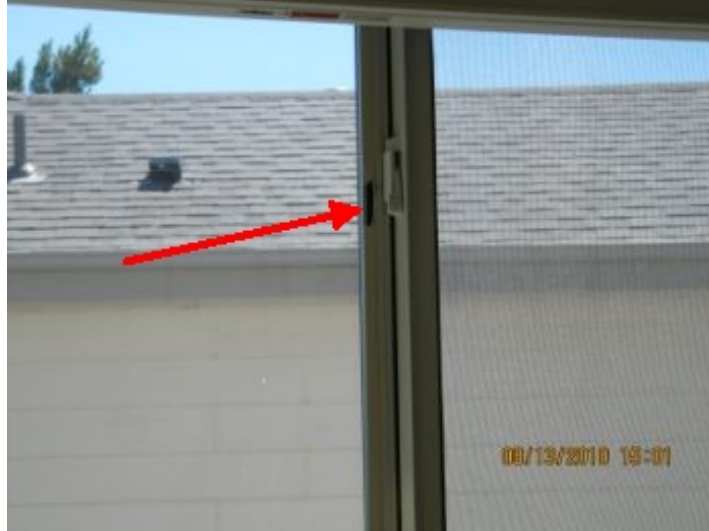
Observations: Vinyl glass stop on fixed side of unit broken.

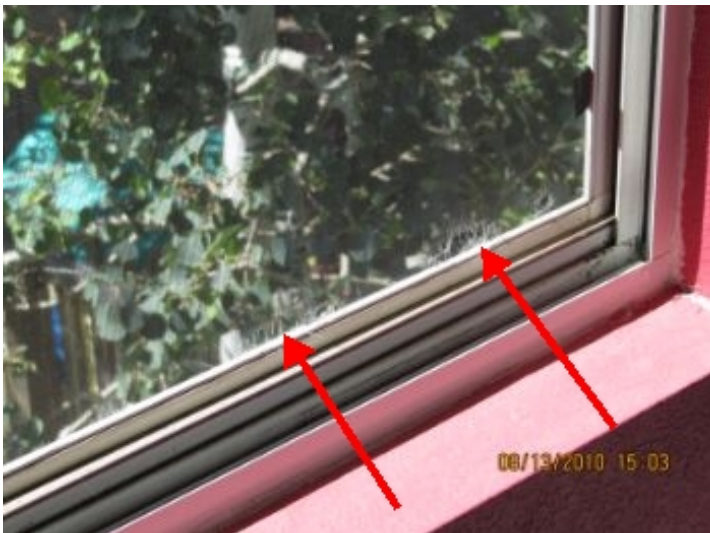
Observations: Damaged screens. • Picture unit on north side of room, glass is fogged, insulated unit seal has failed.

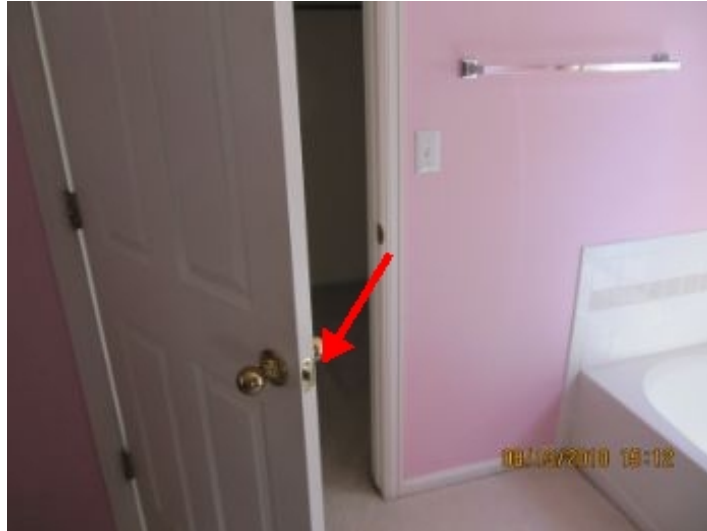
Observations: Closet door does not latch.

Does not latch

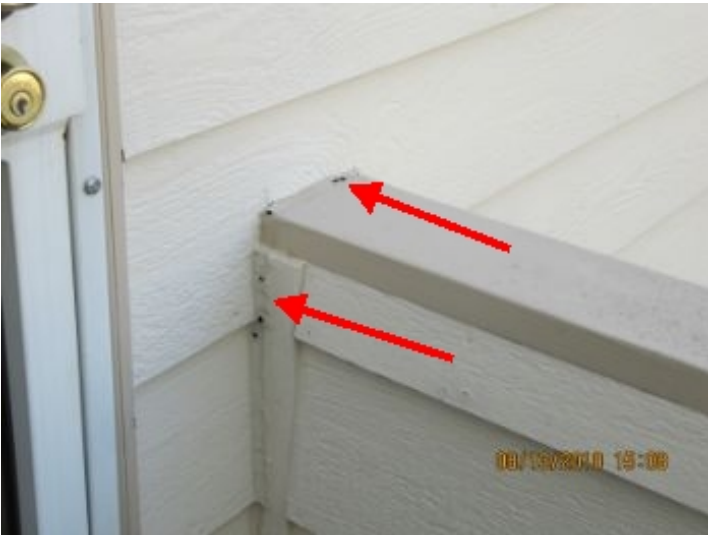
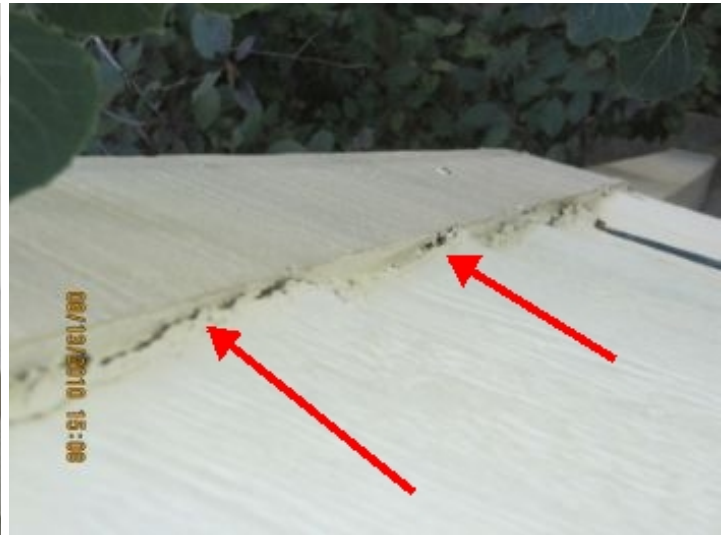
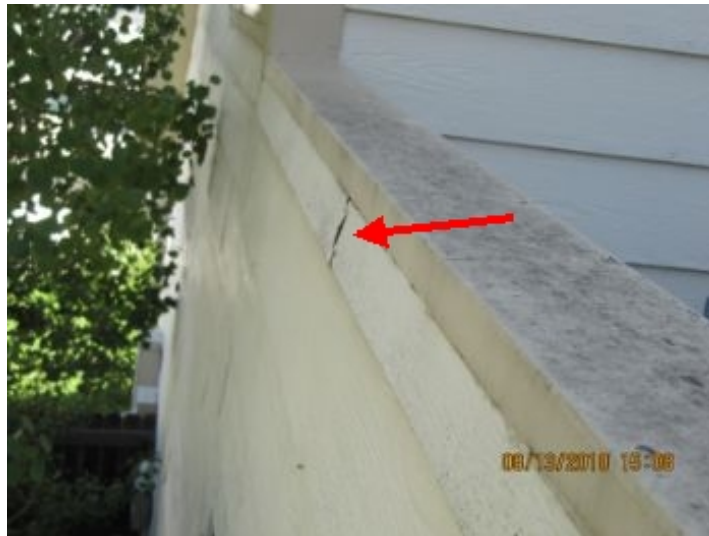
Observations: Deck off north side has settled and pulled the rail/wall away from the house. The gap has been caulked but there are holes through the caulking that need to be re-sealed to keep moisture out of the wall. • Some of the trim directly under the wall cap around the deck is water damaged and rotten and should be replaced. • The wall cap needs to have flashing installed beneath it and over the top edge of the trim and siding on the wall to keep moisture from seeping in to the wall system and deteriorating it further. • The siding on the outside of the deck rail/wall needs to be caulked to the trim where the caulking is cracked out. • The trim around the bathroom window above the deck is rotted and needs to be replaced.

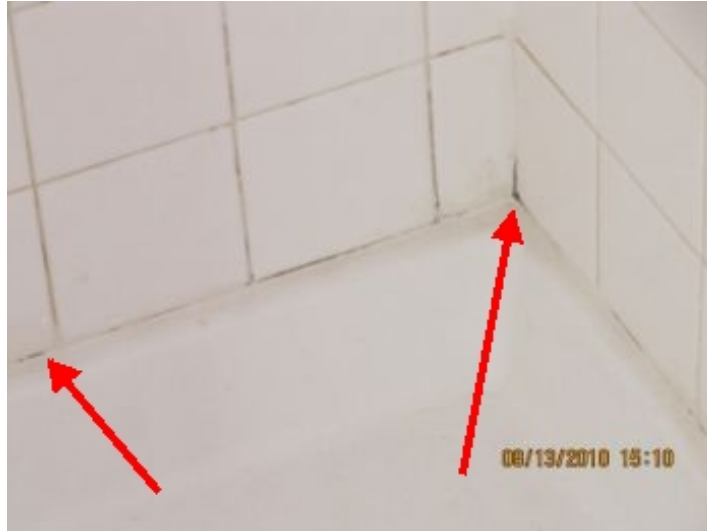
Observations: The joint between the tile and the base needs to be re-caulked as the caulking is cracking and mildewed.

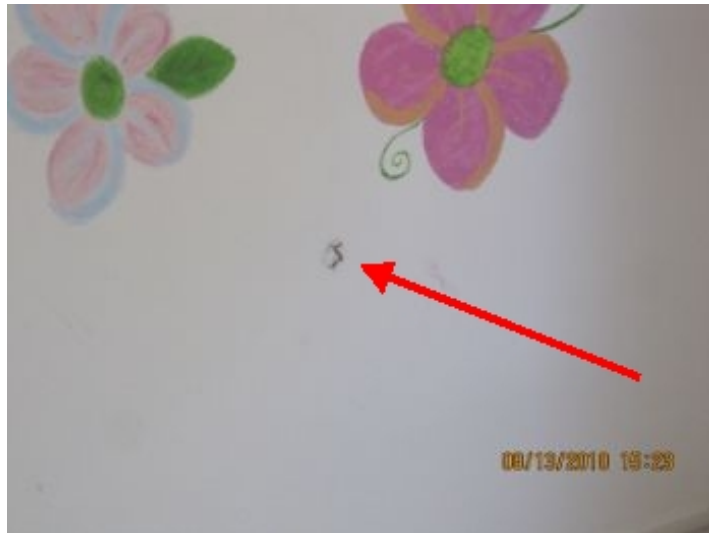
Observations: Some holes punched in the walls here and there.

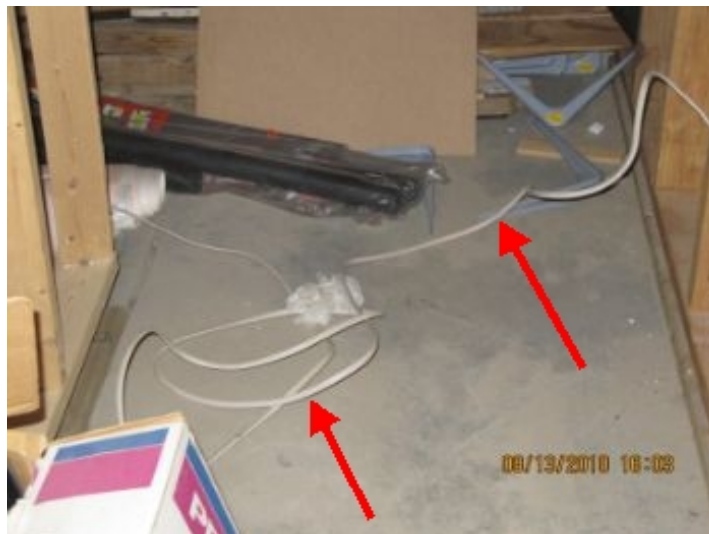
Observations: All wiring should be properly secured to the framing. • An additional electrical outlet has been added on the framed wall next to stairs. Power has been provided by a wire run from one box to another under the stairs, but the wire has not been secured to the framing, it is just laying on the floor. • All wires should be secured within 12" of an electrical box and every 6' thereafter.

Wiring needs to be secured to framing and protected

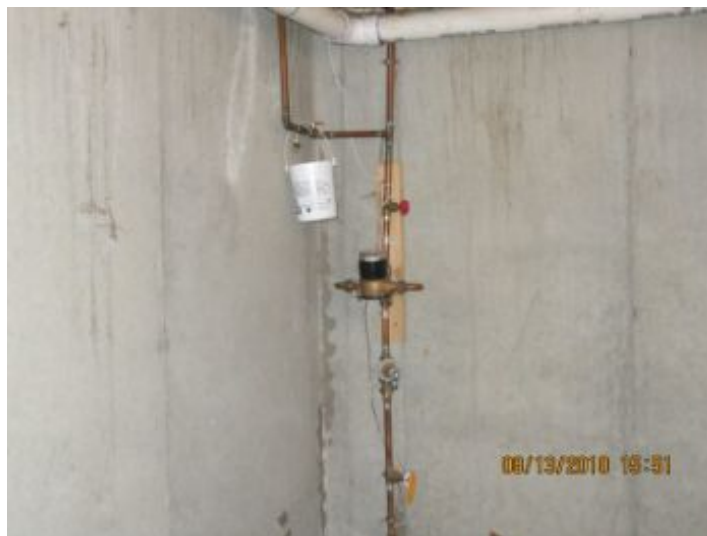
Materials: Basement • Northeast corner
 Observations: Brass Gate Valve • 3/4" Copper Main Water Line • The electrical system ground wire is observed attached to the main copper water line within 5' of where it enters the home. • Gate valves become corroded over time and will fail to shutoff completely, it is recommended than an older valve such as this be replaced with a ball valve to assure the ability to positively shutoff the water off to the home if it becomes necessary. • The lawn sprinkler system shut-off is also in this location, along with a valve to drain down the sprinkler backflow preventer for winterization. • The PRV (Pressure Reducing Valve) in this location can be adjusted to reduce or increase the water pressure in the home.

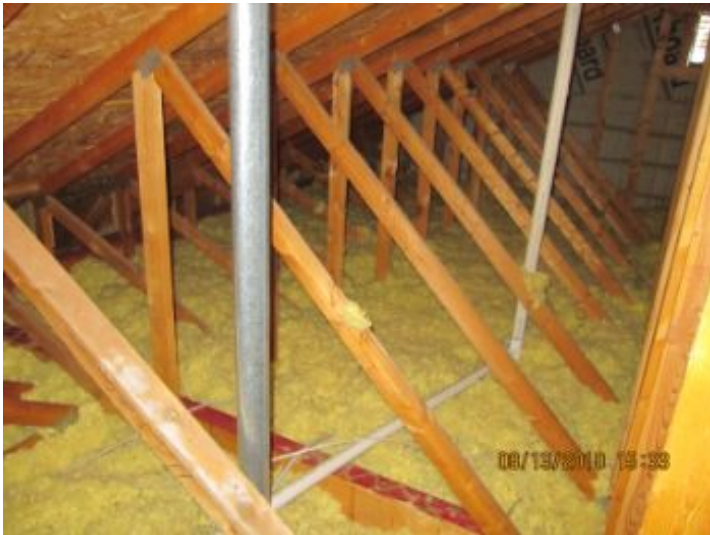
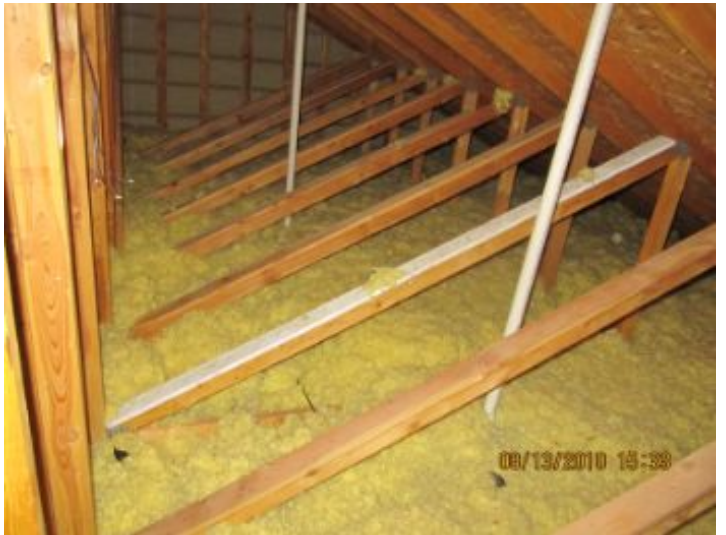
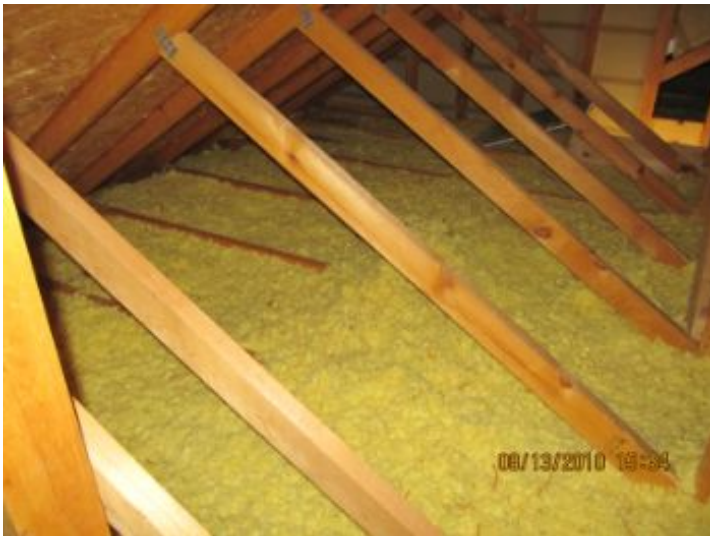
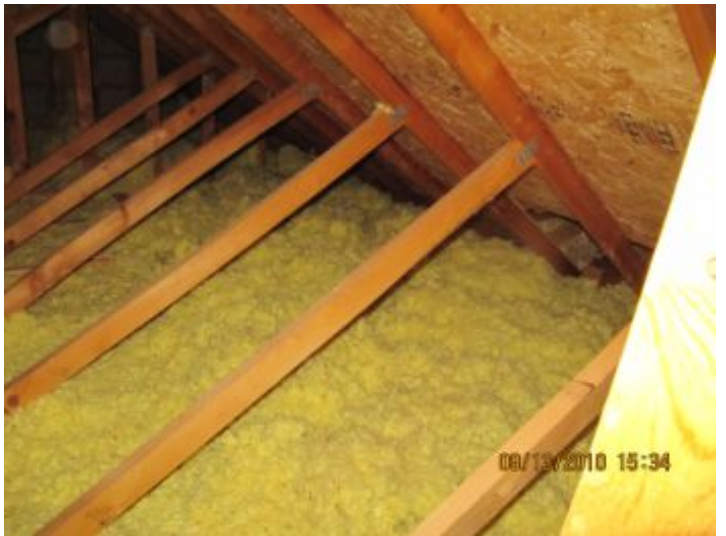
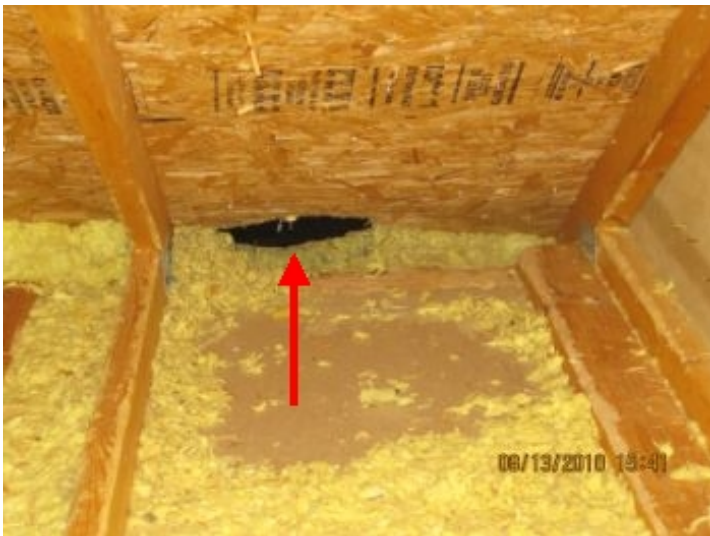
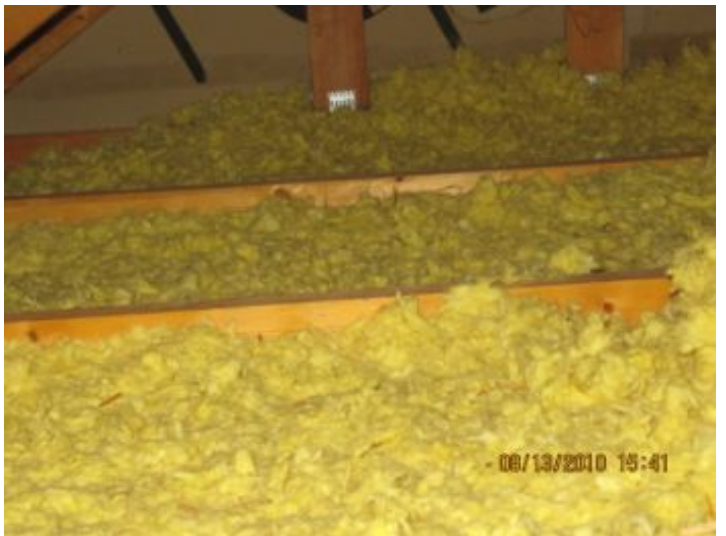
Observations: 8-10" of insulation present. • The insulation appears to have been raked or blown away from the north side of the attic leaving from 0 - 3" of insulation in this area that looks as if it has been compressed by moisture. The insulation appears to be stacked up in the center of the attic space in this area. The rest of the insulation in the attic appears to be relatively evenly distributed.

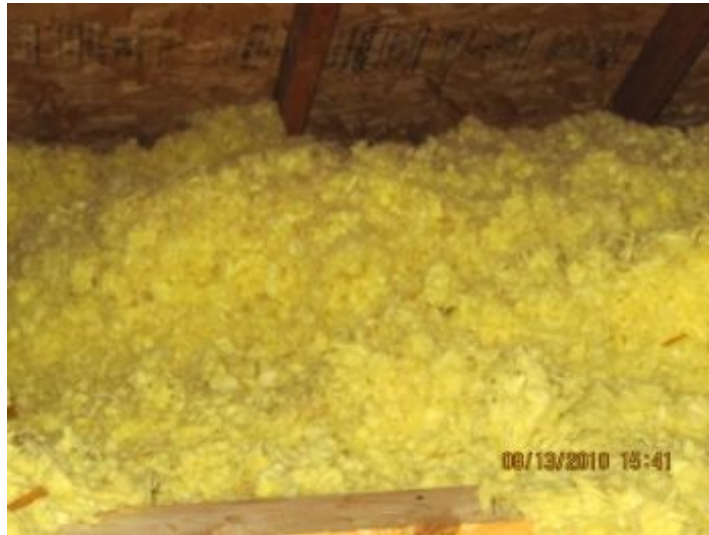
Hole in sheathing

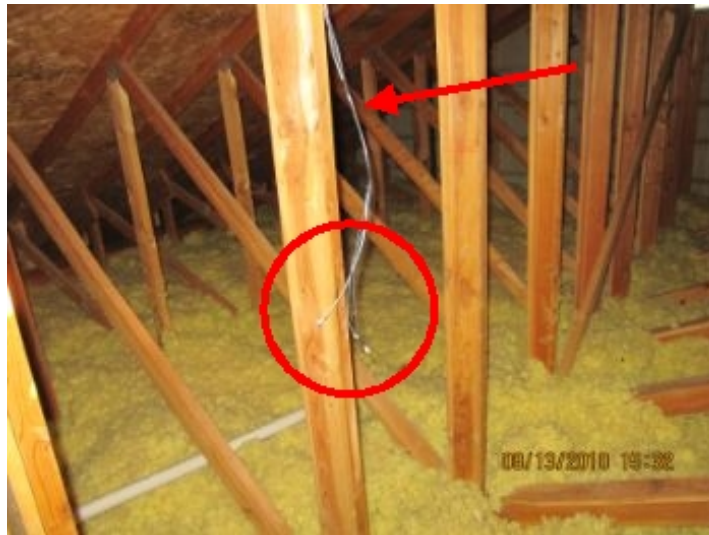
Observations: There is approximately a 5 ft. piece of wiring that has had the insulation chewed off of it by squirrels. • There is an electrical outlet box more toward the center area of the attic that has three individual wires coming out of the box, the ends appear to be taped, but the black wire has power to it. • Recommend having these issues repaired by a licensed electrician.

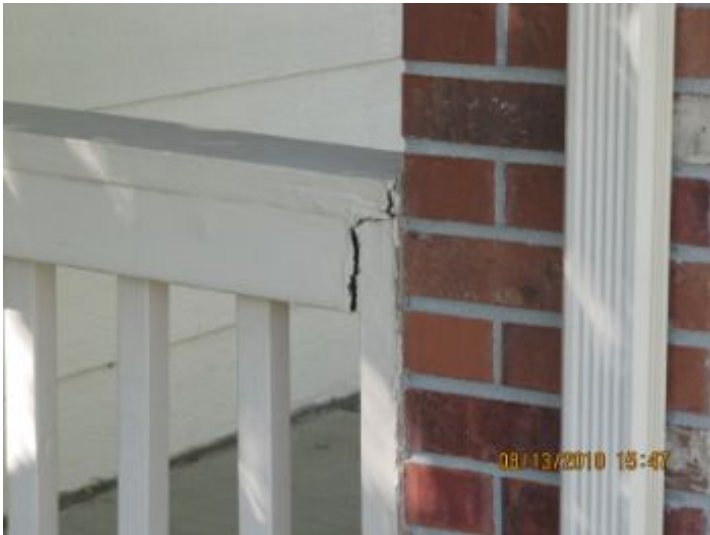
Observations: It appears that the southern most brick column has settled and leaned approximately 3/4". The concrete slab on that side of the porch has been re-poured suggesting that this entire corner of the porch settled. The column does not appear to be supporting the roof above it, but it seems that it should. It seems that the column is only cosmetic. It may need to be removed and re-built to correct the lean and to realign it with the rest of the house, and to get some support under that corner of the porch roof. While this does not appear to have adversely affected the structure in any way it may be advisable to consult with a structural engineer as to the best method of repair.

Railing pulled apart, needs caulking

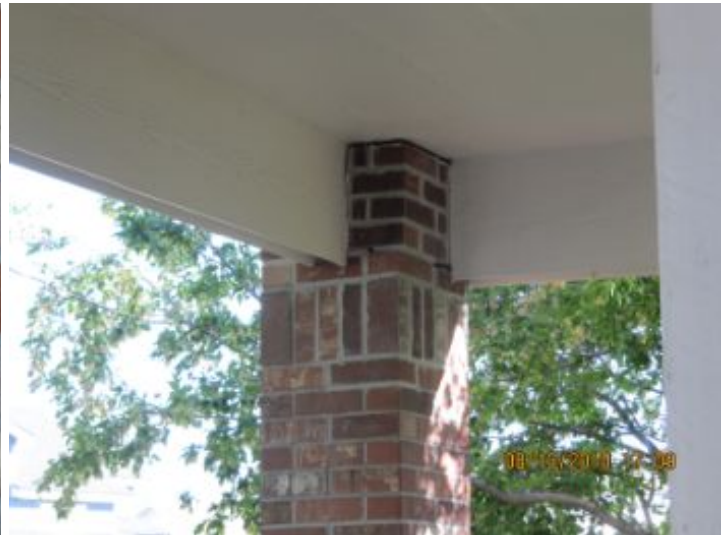
Column has settled, top portion of brick loose

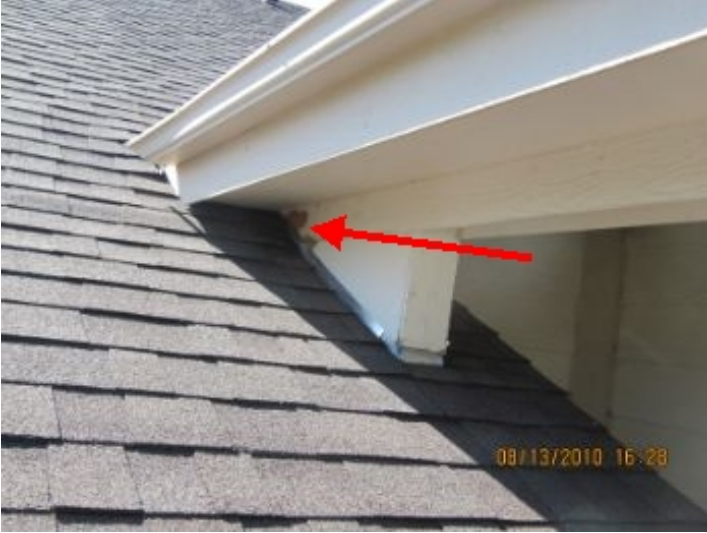
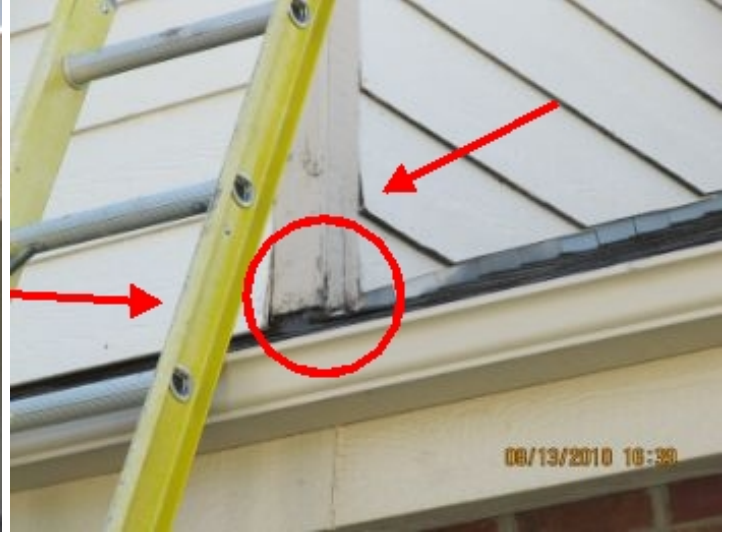
Observations: Overall the siding appears to be in serviceable condition. There are some places where it is loose and the nails have backed out, but that can be easily remedied. At some of the exterior corners and up against the window trim the siding needs to be caulked to the trim.

Loose siding, trim weathering

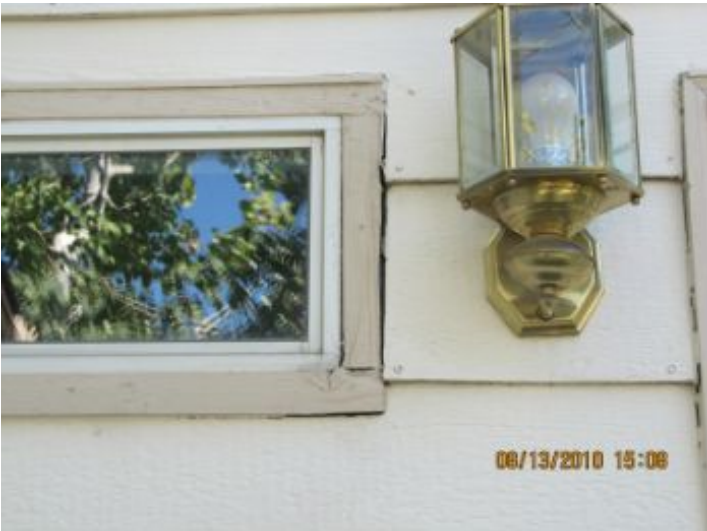
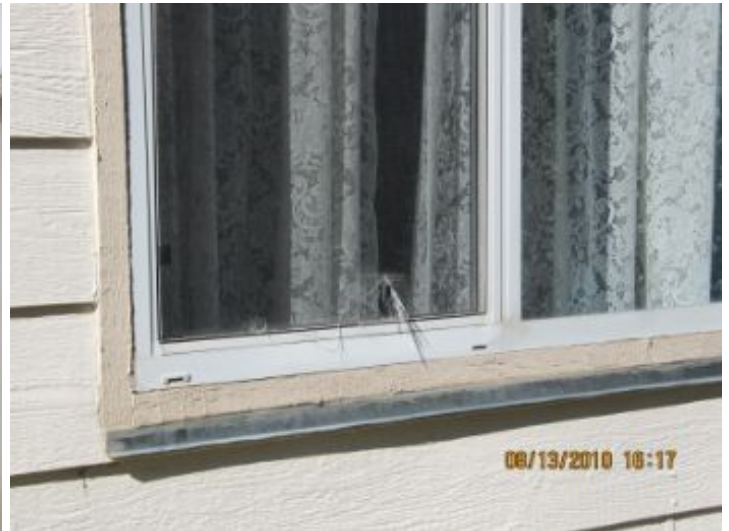
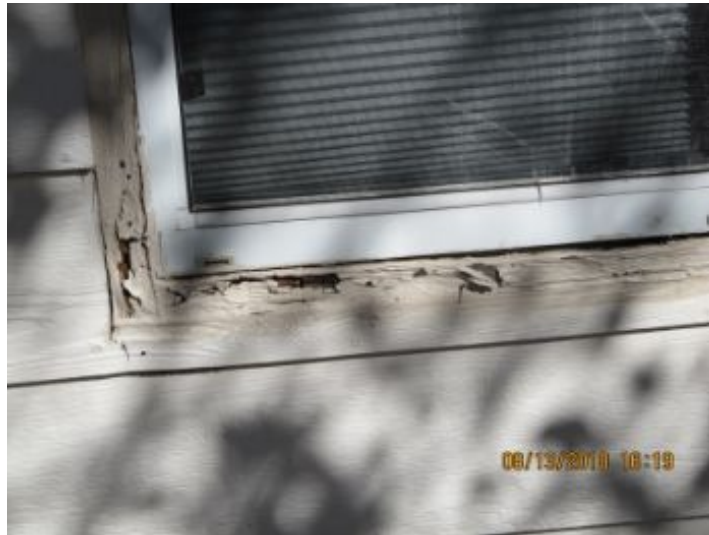
Observations: Most of the trim is in serviceable condition but there are some windows, like the bathroom window on the master bedroom deck, the family room window on the rear deck, and the bottom ends of the corner boards above the lower roofs that have rotted and need to be replaced or are badly deteriorated.

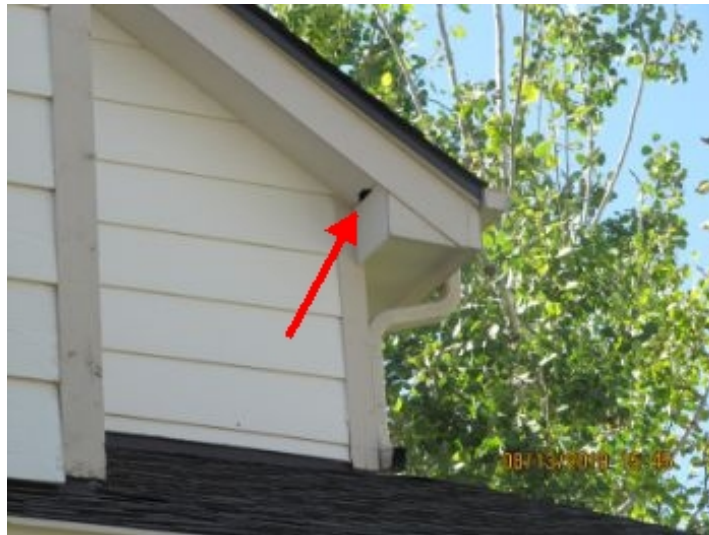
Hole where squirrels gained access to attic

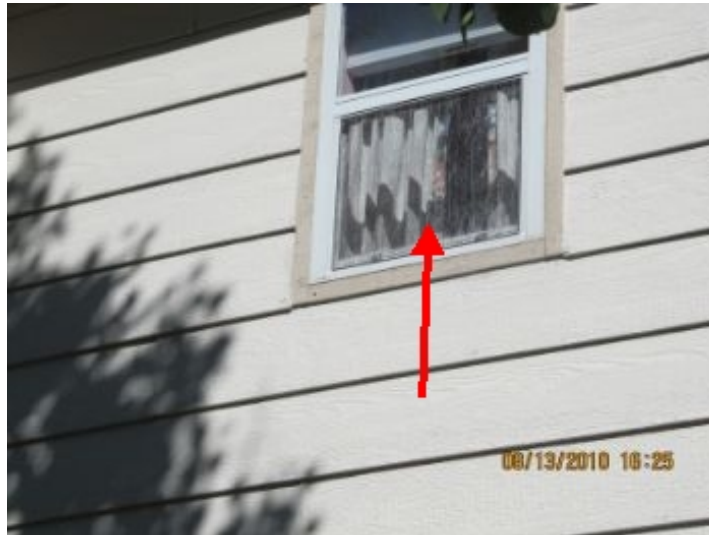
Appears Serviceable
 Significant Deficiency
 Safety Hazard
 Repairs Recommended
 No Comment
 Observations: Insulated glass window seal has failed in the master bedroom picture window unit as evidenced by the condensation/clouding observed in the windows. The seals of the insulated glass units having failed is not only unsightly it also compromises the thermal efficiency of the windows. It is advisable that they be repaired or replaced. • Damaged screens.

Bad screen

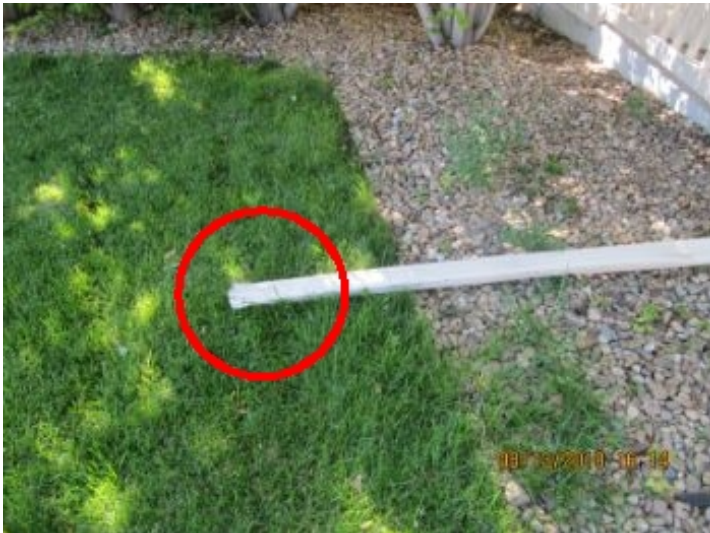
Observations: Downspouts should discharge 5' from the foundation to contribute to proper site drainage and prevent moisture from draining into the soil at the foundation creating the potential for foundation damage. • Missing downspout extensions on the rear of the house. • The extension on the southeast corner at the front of the house is smashed on the end and likely does not drain as it should.

End smashed

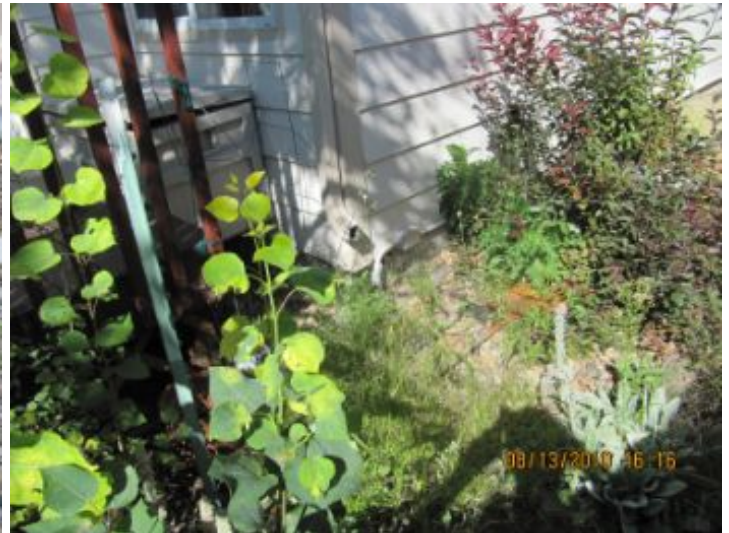
Extension missing

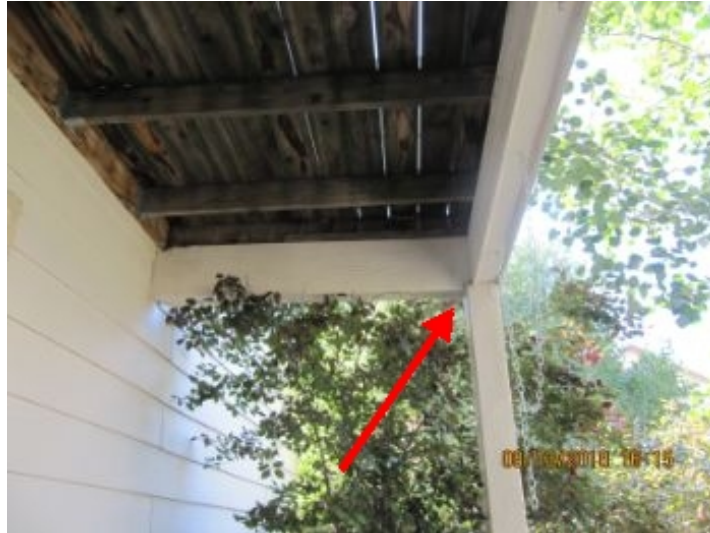
Observations: There appears to be an original deck and an add-on. There is some slope to what may have been the original deck that appears to be the result of the supporting posts having settled. It seems that the deck supports are mounted on concrete pads but there is no way to determine their depth. The structure appears to be sound.

Post has settled

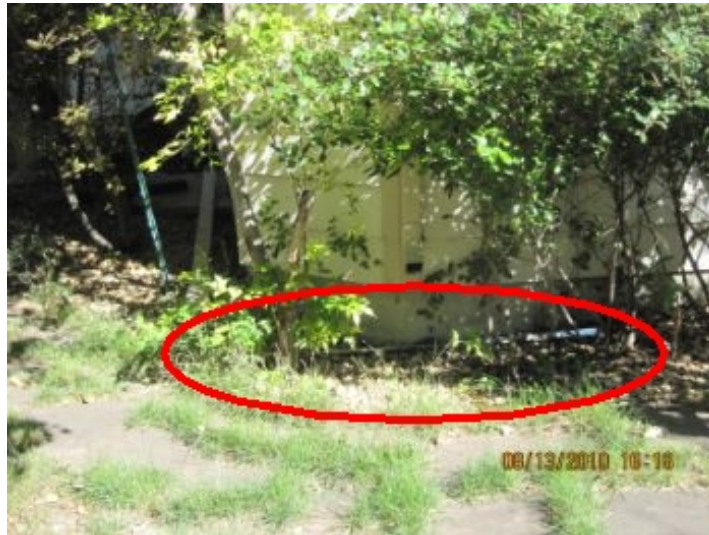
Observations: Flat Lot • Older homes do not have the same drainage features as newer homes, making them more vulnerable to water infiltration. • For the most part there appears to be positive drainage away from the house • Current building standards recommend that the dirt grade around a home slope away from the foundation at the rate of 6" of fall within the first 10' away from the foundation. • While this may not be attainable on an older home it can be used as a guideline to assist you with what needs to be accomplished in order to establish positive drainage away from the home. • At the northwest rear corner of the house the ground has settled creating a low spot that allows water draining from the roof by means of the downspout to settle into this area with nowhere to drain but into the ground against the foundation. The grade in this area needs to be raised to establish positive drainage away from the foundation.

Low area

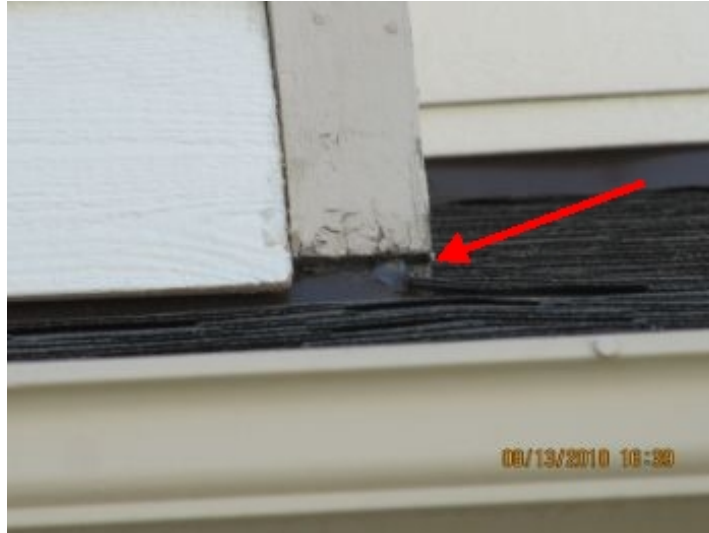
Observations: One exception is at the northeast front corner of the house above the garage roof where the flashing at the corner has a gap that may allow moisture to get behind the flashing and under the shingles.

Hole
